(9) Special Report/80-14

(11) March 1980

(6) CRREL ROOF MOISTURE SURVEY, PEASE AFB  
BUILDINGS 35, 63, 93, 112, 113, 120 and 220.

(10) Charles Korhonen and Wayne Tobiasson

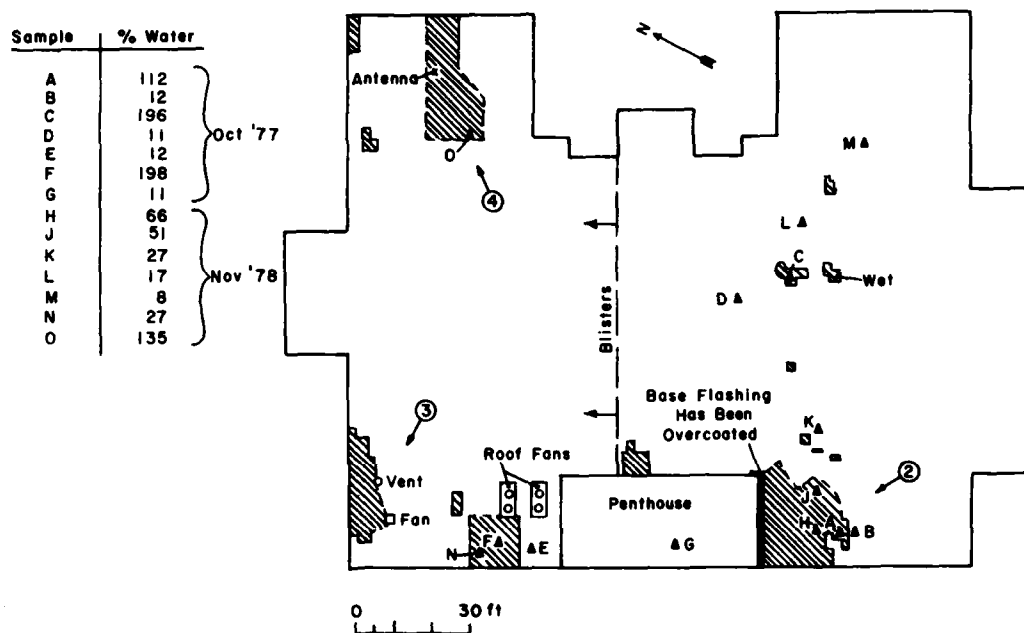
The roof on this building comprises a gravel-covered, built-up membrane underlain by 2 1/4 in. (5.7 cm) of wood fiber insulation. We identified several areas suspected of containing wet insulation (shown by the hatched areas in Fig. 1).

Several small blisters were noted in the northern portion of this roof (left of the dashed line in Fig. 1). Brief visual examinations of this roof were made in September and November 1978. At those times blisters were present over the entire roof, suggesting progressive membrane deterioration.

Figure 1. Plan view of Building 113. On all roof plans, circled numbers indicate the location and viewing direction of thermograms or photographs, dotted lines are general boundaries, and solid lines are exact boundaries of wet areas, which are depicted by hatching.

Since only a small percentage of this roof contains wet insulation but the entire membrane appears to be rapidly deteriorating, we suggest that all the gravel be removed and the tops of all blisters cut away. All wet insulation should then be cut out and replaced with dry insulation. Additional insulation should be added over the entire roof to improve its thermal resistance. It may be possible to affix the new insulation to the existing membrane with hot bitumen, but it may be necessary to use mechanical fasteners.

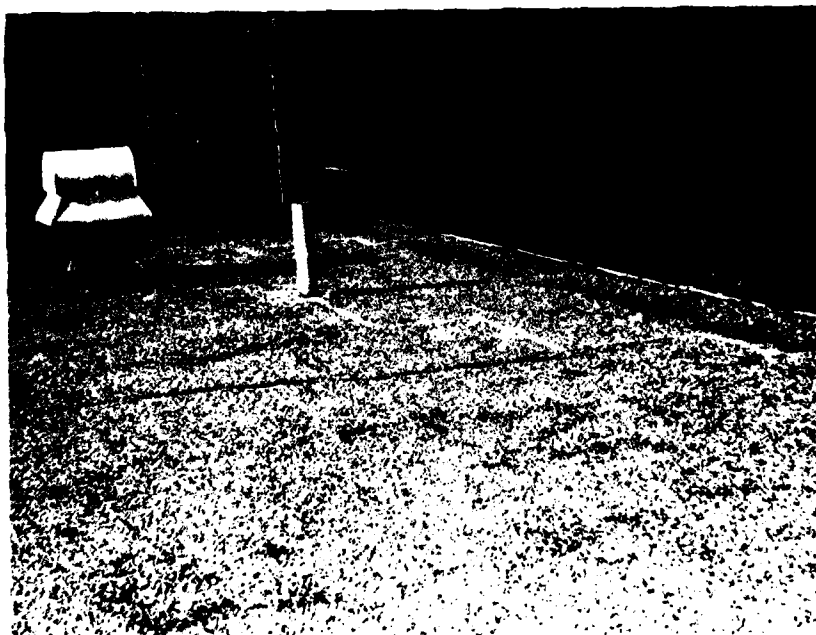
Thermograms and photographs of three large wet areas are shown in Figures 2 - 4. We suspect that flashing defects and punctures in the built-up membrane are the cause of these wet areas even though we did not observe any during this survey.

Figure 3. Thermogram and photograph of wet area that appears to be emanating from the base of a roof fan, Building 113.

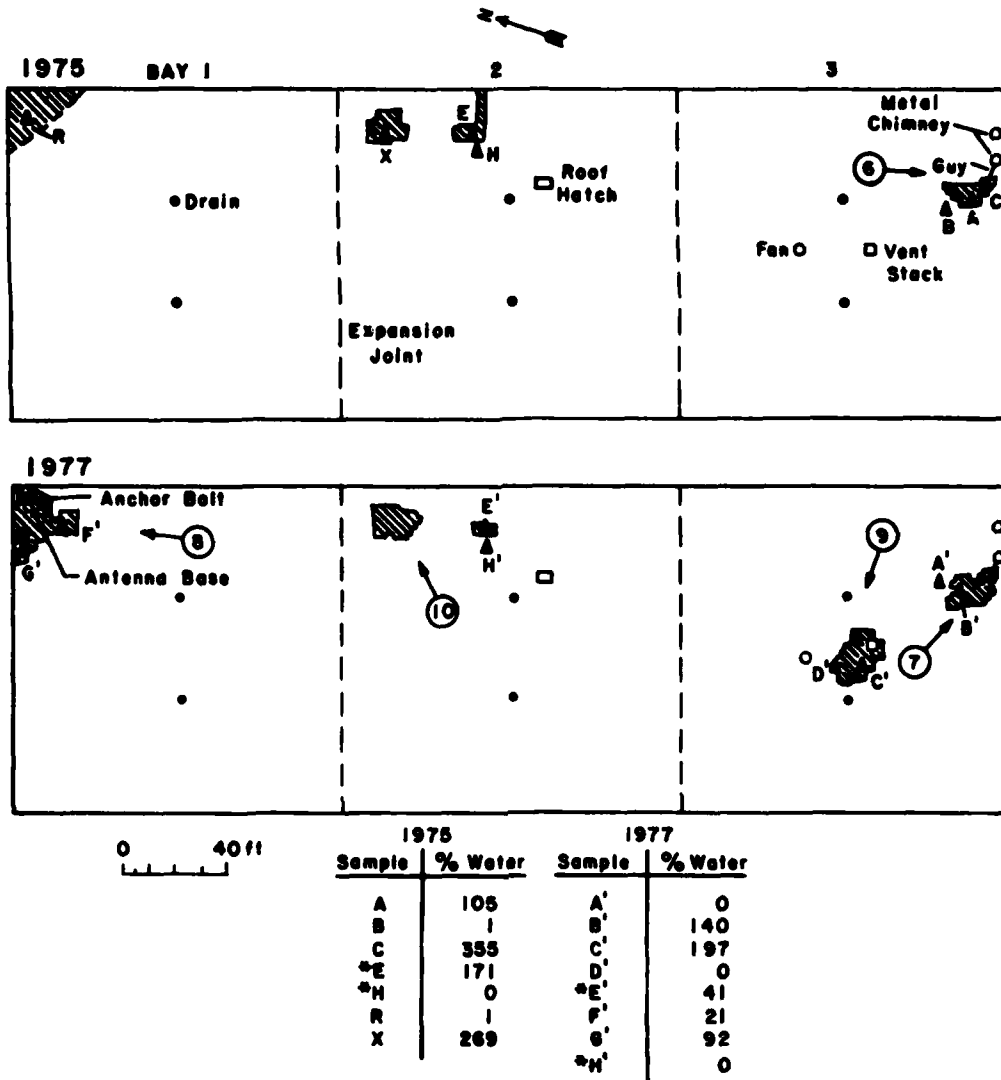
Figure 5. Plan views of the 1975 and 1977 survey results for Building 120.

Figure 5 presents the results of the 1975 and 1977 surveys. The number and size of wet areas have greatly increased, indicating that moisture is entering the roof. One contradiction exists: the wet area surrounding sample E (Fig. 5) decreased in size and water content. This area may have lost moisture through the edge of the roof.

Low blisters were noted over much of this roof and the membrane from each sample was brittle. We expect that a new built-up roof will be required shortly. Rather than wait until severe leaks occur, we suggest that the gravel be removed from this membrane and all areas of wet insulation be cut out and replaced with dry insulation. A new layer of insulation, perhaps mechanically fastened to the deck, should be added over the entire roof and a new gravel-covered built-up roof installed.

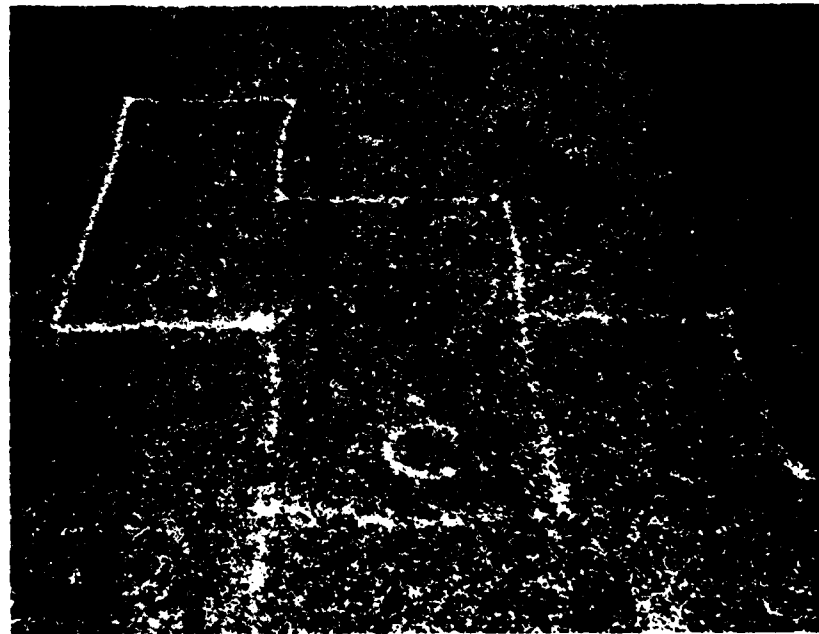
We consider membrane punctures created by guy wire anchor bolts responsible for the wet insulation found at each end of this roof. Figure 6 is a 1975 thermogram of a bright area surrounding the anchor bolt in the southeast corner and a photograph of the same area. From a comparison of the water content of the 1975 Samples C and A (C = 355% and A = 105%) it is evident that the insulation was much wetter near the bolt than at a distance from it, strongly suggesting that moisture enters the roof near the anchor bolt. The thermogram in Figure 7 shows the extent of wetting in 1975; the photograph shows the boundaries painted in 1977.

Figure 6. 1975 thermogram and 1975 photograph of wet area surrounding bolt, Building 120 (arrow points to bolt).

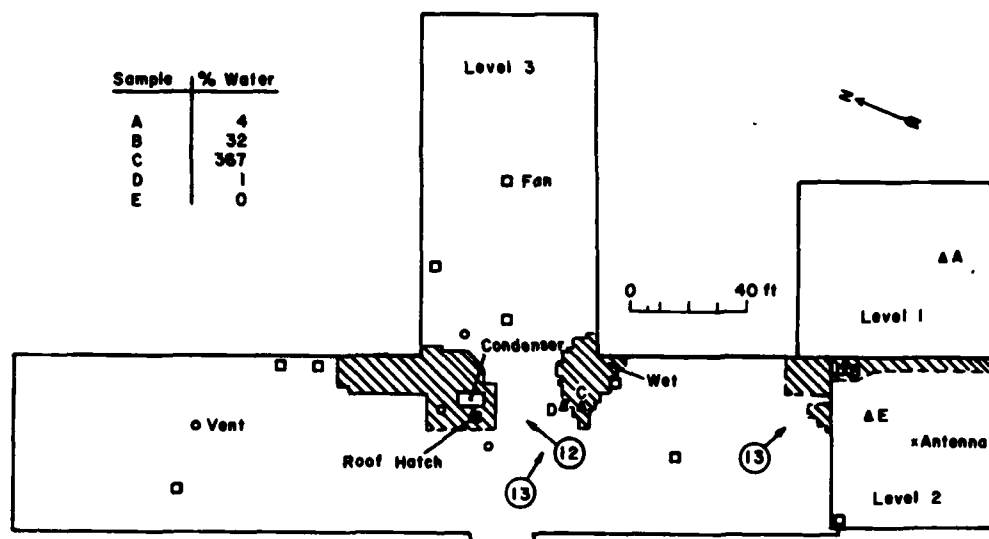
Figure 11. Plan view of Building 35.

This roof is composed of three levels (see Fig. 11). Approximately 2 ft (0.6 m) separates each level, with Level 1 the highest and Level 3 the lowest. Level 1 is gravel-covered while Levels 2 and 3 have a gravel surface that is over-coated with a bituminous seal coat. Overall, Level 1 appeared much brighter than the other two levels when viewed with the infrared camera. Core samples revealed that Level 1 had wood fiber insulation which is only 1/2 in. (1.3 cm) thick, while Levels 2 and 3 had glass fiber insulation 1 1/2 in. (3.8 cm) thick. Thus the thermal image was brighter on Level 1 because that section had less insulation than the other two levels. Because the Level 1 roof was uniformly bright we expected it to be free of wet insulation. Sample A, taken on Level 1 (see Fig. 11), was dry, which verified this expectation. Visually, the built-up membrane on Level 1 appeared to be in excellent condition. No remedial work is necessary there.

Five thermal anomalies were detected with the infrared camera on the Level 2 and 3 roofs. They are shown as hatched areas in Figure 11. Core samples subsequently verified that the insulation in these areas was wet. Figures 12 and 13 show a thermogram and three daytime photographs of these wet areas.

Unlike sample A, the membrane of samples B through E was brittle. It delaminated during the sampling process. This lack of interply bonding indicates that the membrane is very aged and probably will not last much longer. Due to the heavy over-coating on levels 2 and 3, we do not feel that the gravel can be removed without damaging the glass fiber insulation. We expect that simply cutting out and patching the wet areas is not an economical repair alternative because the entire membrane is so old and brittle. We recommend that all the membrane and insulation on Levels 2 and 3 be removed and replaced with new, insulated, built-up roofing.

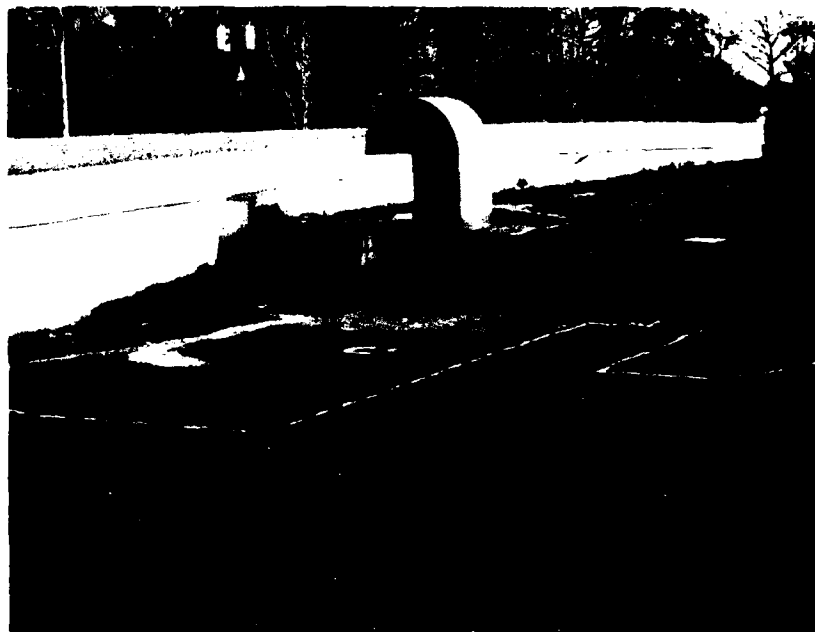
Visually, only one obvious moisture entry point was uncovered. The arrow in Figure 13 points to a deep split in the over-coating. It is likely that moisture entered the roof at this location. Building occupants pointed out two sections of ceiling stained by leaks which occur each winter. One leak is under the split shown in Figure 13; the other leak coincides with the area shown in Figure 12.

Figure 13. Wet areas on roof of Building 35 (arrow points to a split in the roof membrane).

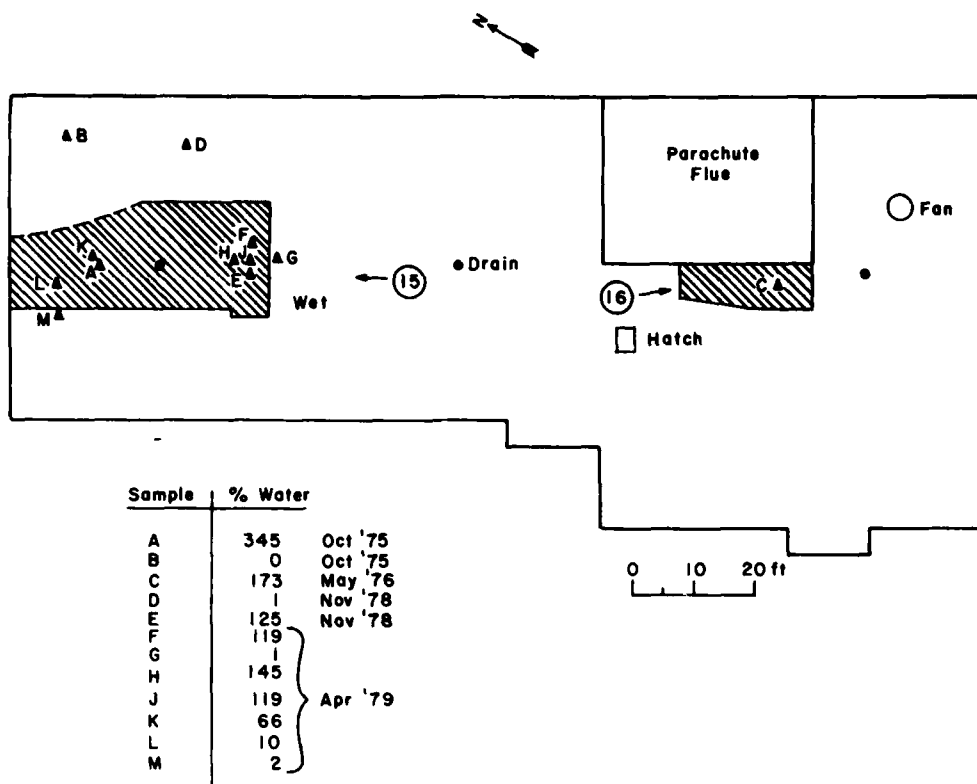
Figure 14. Plan view of Building 112.

Infrared surveys were conducted on the main roof of this building in October 1975 and in May 1976 in addition to this survey (October 1977). Brief follow-up surveys were also conducted in November 1978 and April 1979. Essentially the wet areas shown in Figure 14 have been detected each time. The main roof consists

Once repair work does become necessary, we recommend that a process similar to that outlined for Buildings 113 and 120 be followed.

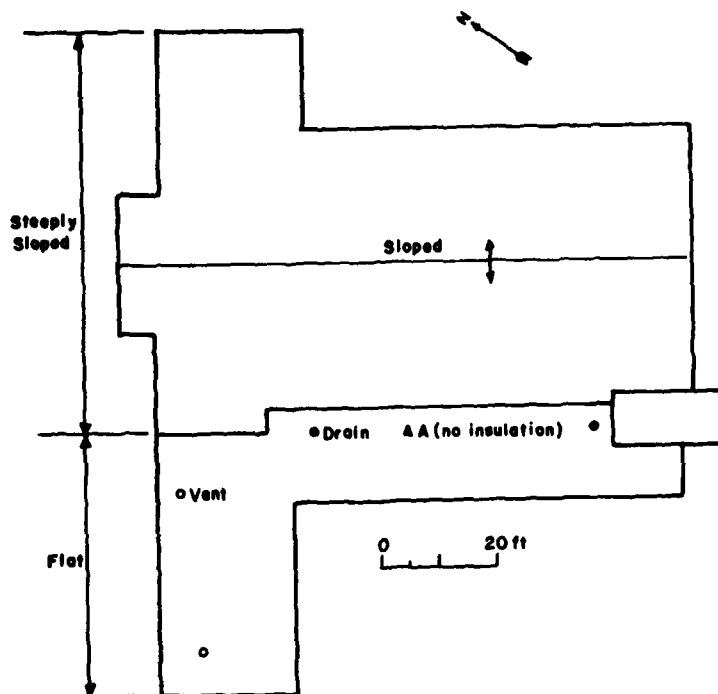
We detected subtle thermal anomalies unrelated to entrapped moisture on the flat portion of this roof (Fig. 17). The main roof is steeply sloped and was not surveyed. The anomalies were attributed to variations in surface color caused by differences in the extremely heavy bituminous overlays previously applied to this roof. Sample A showed that there is no insulation above the wood deck so we cannot make recommendations based on entrapped moisture.

Figure 17. Plan view of Building 63. The sloped portion was not surveyed. The flat area contained subtle thermal anomalies when viewed with the infrared camera.

Visually, the base flashings appear to be in good condition. Although the overlay is dry and cracked, the membrane of sample A exhibited good interply bonding. Barring any leaks, we feel that a few more years of serviceable life can be expected from this roof. The heavy overlay will hinder any patching attempts. For this reason and because this roof is rather small, we suggest that the existing membrane be replaced by a new built-up membrane and insulation if leaks develop.

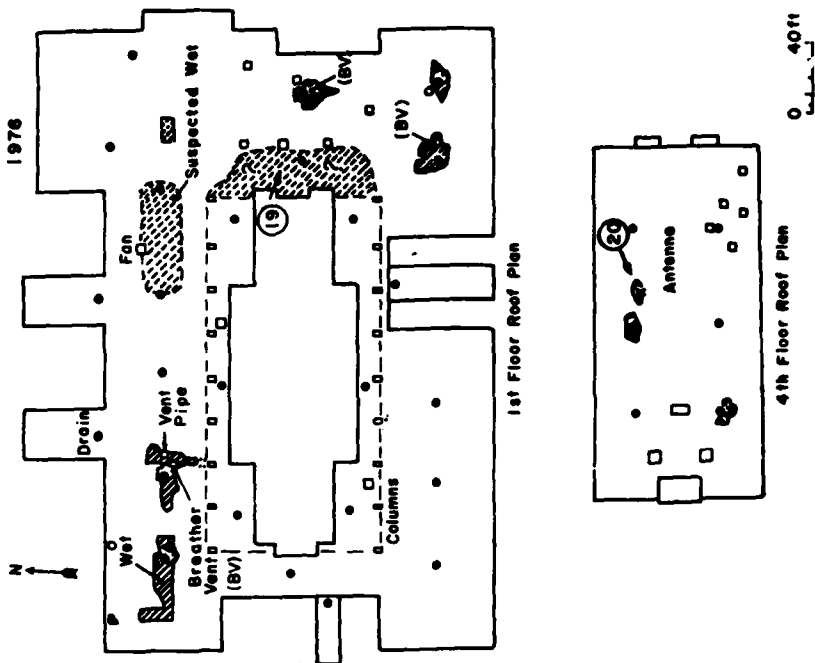
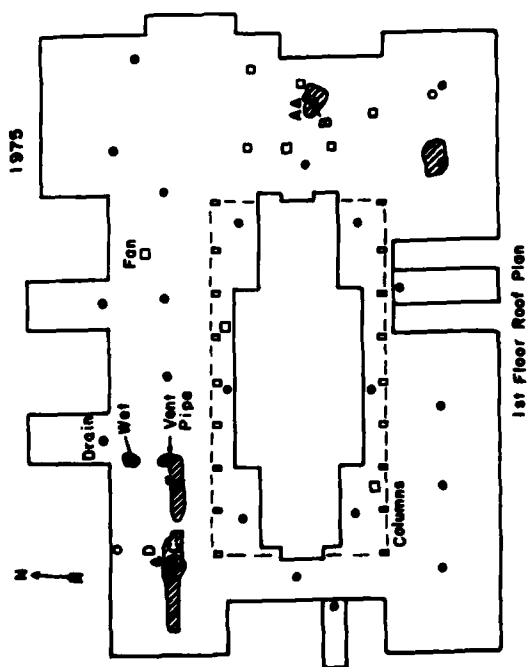
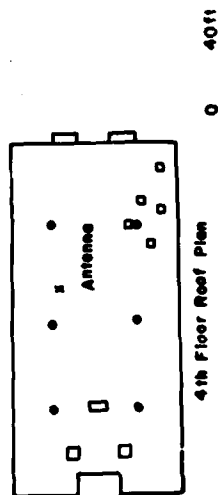
Figure 18. Plan view of Building 93. Because no samples were taken in 1976, dashed hatching is used to indicate suspected wet areas which were not wet in 1975.

roof generally show that most areas of wet insulation are associated with membrane penetrations, especially roof drains (Fig. 18).

Five areas of wet insulation were uncovered during the 1975 infrared survey (Fig. 18a). Since the roof was still under warranty, the contractor decided to patch all visual defects in flashings and install insulation breather vents in an attempt to dry these areas.

In 1976 seven new "suspected wet" areas were also detected. They are shown by dashed hatching in Figure 18b. They are termed "suspected wet" since no samples were taken in 1976. These "suspected wet" areas strongly suggest that in 1976, moisture was entering the roof at several membrane penetrations. Three of these areas were located on the fourth floor roof which had not contained any problem areas in 1975. Two are shown in Figure 20. We examined the drains in this area and in one case found that the lead flashing was not well bonded to the membrane. We also noted numerous flashing flaws (Fig. 21).

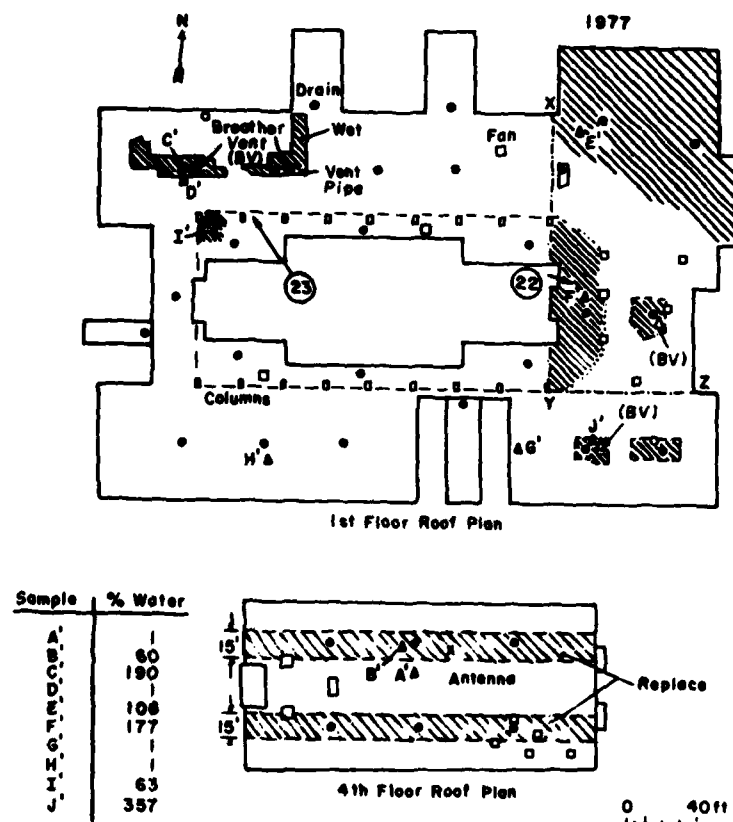
Figure 18. (cont'd) Plan view of Building 93.

The 1977 survey (Fig. 18c) revealed even greater wetting of the insulation. Figure 22 shows a larger wet area than that in Figure 19.

The wet area in the northwest corner of the lower roof is shown in Figure 23. Breather vents installed within this wet area have not been able to dry it out. Sample C' (Fig. 18c), which was taken in 1977 close to 1975 sample C (Fig. 18a), showed the moisture content increasing from 132% in 1975 to 190% in 1977. Although this roof is continuing to collect moisture, core samples indicate that the membrane is in fairly good condition. If the leaks can be eliminated, several years of serviceable life can be expected from this membrane. Therefore, we suggest that only the membrane and insulation in wet areas be cut out and replaced with new dry materials. Extra attention should be directed toward effective sealing of flashing and roof penetrations to avoid a repetition of the current problem.

The wet area where sample E' was obtained (Fig. 18c) was not well defined. It is possible that internal moisture from the kitchen caused insulation in this area to accumulate moisture. The same argument can be advanced for the area surrounding sample F'. Wetting of that area might also be explained by entry of driving rain along the east wall of the high portion of the building. If these areas are cut out and replaced, attention should be given to achieving a continuous vapor barrier along this wall and providing effective cap flashing where the wall and roof abut. Because the root cause of moisture for this area is not well defined, it may be wise to replace all roofing and insulation to the north-east of dashed line XYZ in Figure 18c. A tight vapor barrier should be installed and the insulation should be edge-vented to prevent creation of a vapor trap.

The northern valley of the high roof accumulated considerable moisture from 1976 to 1977. Some early signs of moisture entry were also detected in the

southern valley of that roof. We recommend that a 15-ft (4.6-m) wide strip of membrane and insulation down both valleys be removed and replaced with dry insulation and a new built-up membrane. The four parallel dashed lines in Figure 18c delineate the two areas requiring replacement.

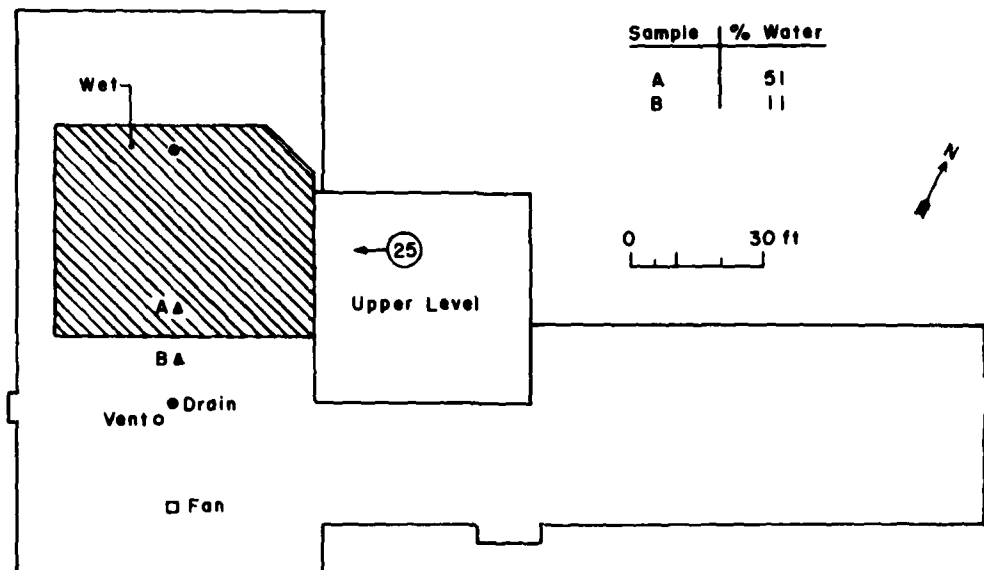
Figure 24. Plan view of Building 220.

This two-level roof consists of a wood deck, 2 1/4 in. (5.7 cm) of wood fiber insulation, and a gravel-covered built-up membrane. One large area of wet insulation was uncovered on this roof (see Fig. 24). The remainder of the roof is considered dry since no other thermal anomalies were detected and since sample B had a water content of only 11%. Building occupants indicated that leaks occurred below the wet area following a heavy rain or snowfall.

Samples A and B show this membrane to be in good condition. The useful life of this roof can be extended by cutting out the portion containing wet insulation and replacing it with dry insulation and a new membrane. By replacing the wood fiber insulation with a similar thickness of more efficient urethane-perlite composite insulation, the insulating value of the roof can be significantly improved.
